Technical Bulletin

Part numbers: L59-110-R, L59-111-R, L59-112-R and L59-113-R

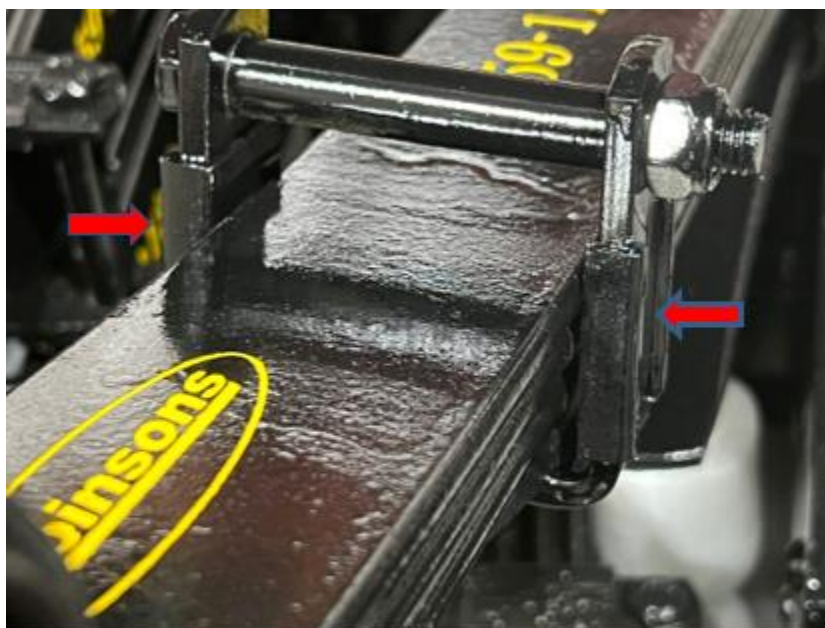
Picture 1

The liners can be found in all the rebound clips on such leaf packs (see picture 1). If one or more of these rebound clips is missing or damaged, the leaves can become out of alignment. In the event of this happening, the 2nd leaf on the pack can contact the shackle. To mitigate this rubbing contact, one must replace the liner and re-centralize the leaves.

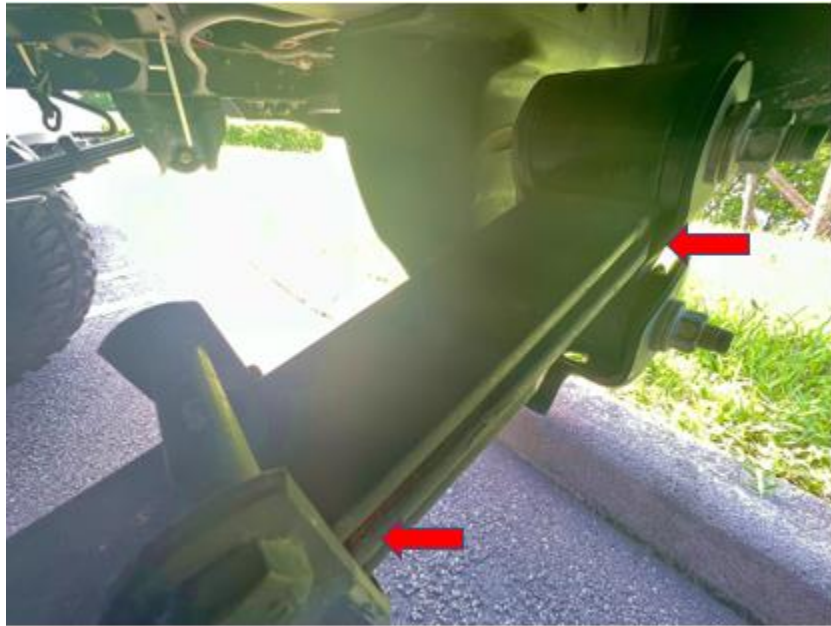
Here is an example of a leaf spring missing the liner and the effect that it has over the leaf pack

Picture 2 shows the second leave out of alignment due to the missing rebound clip liner. To correct this, the 2nd leave must be moved back into alignment by tapping it with a hammer (a piece of wood or a non-marring hammer can be used to prevent damaging the finish). Once the rest of the leaves are centered by following the same procedure, the rebound clip liners can be installed. To do so, remove the top bolt, nut, and sleeve on the rebound clip and reinstall the liner. After the liner is secured in place between the leaf pack and the rebound clip, reinstall the bolt, nut, and sleeve in the reverse order that they were removed.

If you require even more clearance, another option is to grind a bigger notch on the diamond cut of the leaf (see picture 2).

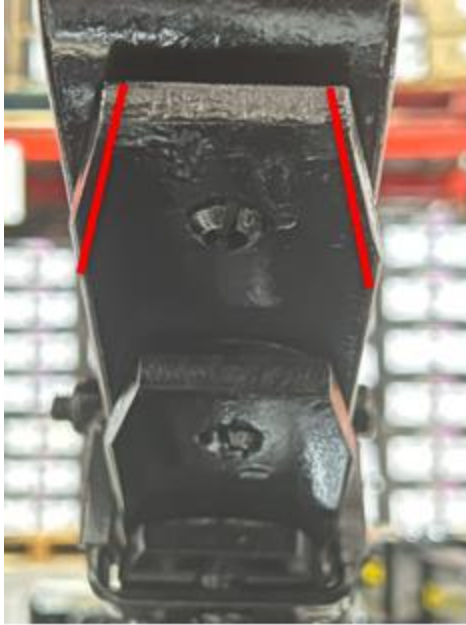
Picture 3

Other reasons that can cause the leaf spring pack to come misaligned:

- Improperly torqued (loose) U-bolts
- Loose center pin/bolt

A bolt check is recommended during the first 500 miles and followed up every 5000 miles.
