TOYOTA HILUX VIGO/
TOYOTA TACOMA

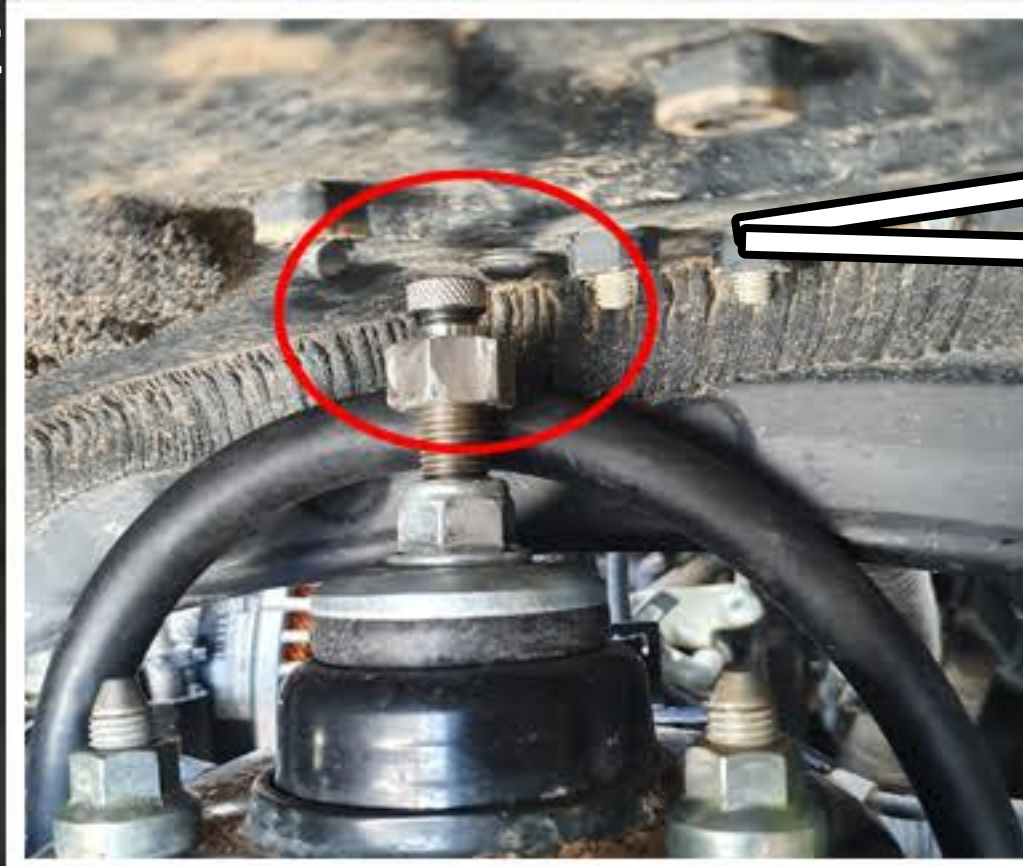
SOME VEHICLES MAY REQUIRE THE FORWARD NUT & BOLT ON THE INNER GUARD TO BE REMOVED WITH A HAMMER AND CHISEL AND THE 6MM DOME HEAD BOLT SUPPLIED INSTALLED FROM THE BOTTOM WITH THE NUT AND WASHER ON THE TOP, AND THE GUARD TAPPED LIGHTLY WITH A HAMMER TO PROVIDE CLEARANCE TO THE REBOUND ADJUSTER

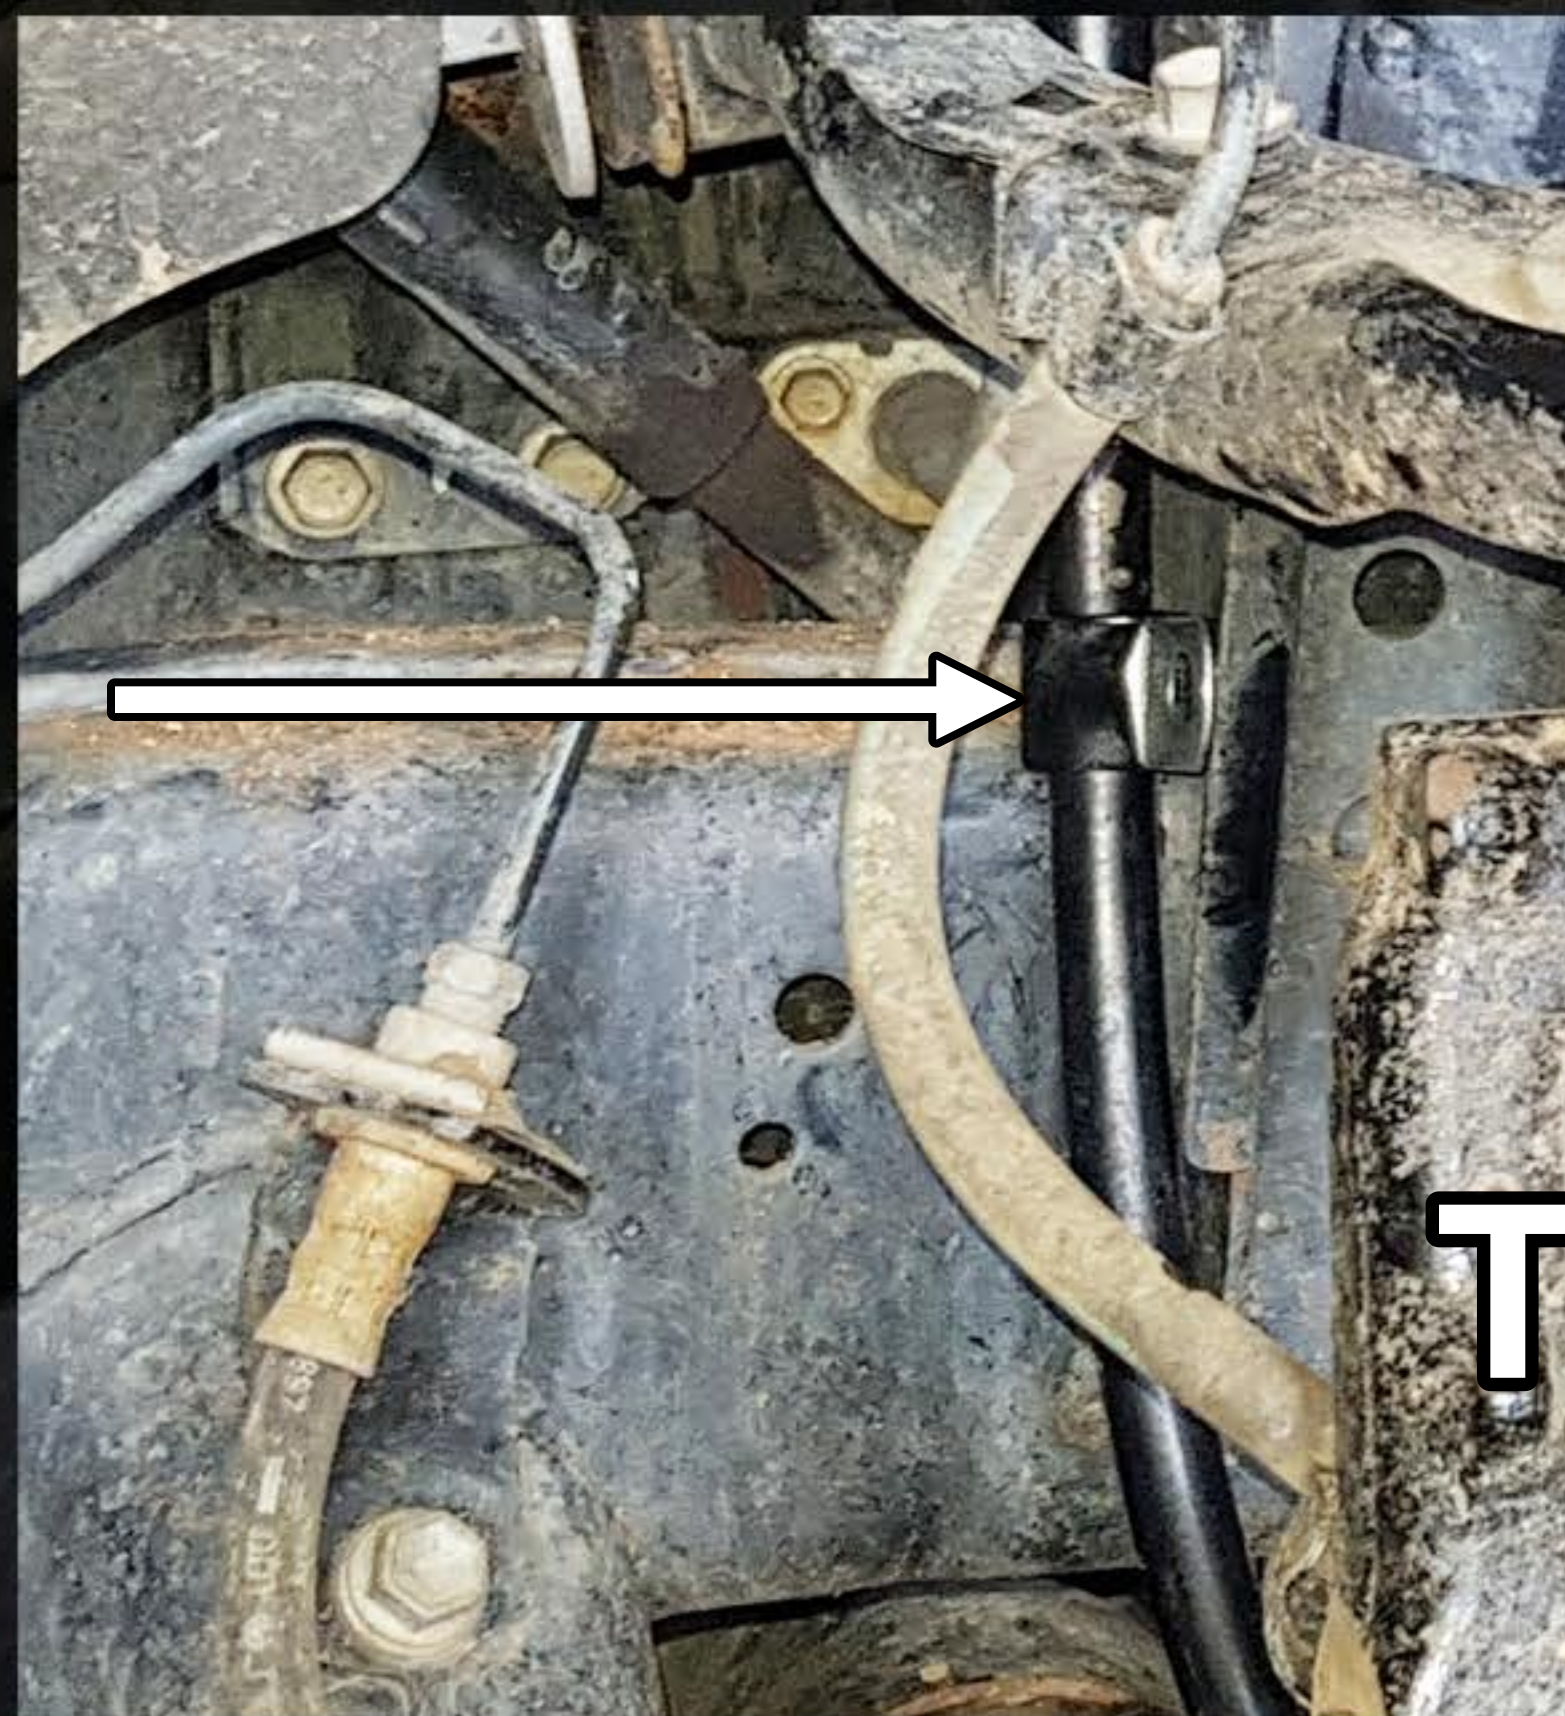
P-CLAMP TOWARDS TOP OF TOWER IN EXISTING HOLE OR DRILL NEW HOLE

HOSE BODY BANJO FITTING ON INSIDE. DRILL HOLE APPROXIMATELY LEVEL WITH TOP OF CHASSIS IN COIL TOWER WITH P CLAMP POSITIONED AS SEEN BELOW AS FAR OUTWARD AS POSSIBLE. FIX HOSE SO IT IS REASONABLY TIGHT AT FULL DROOP.

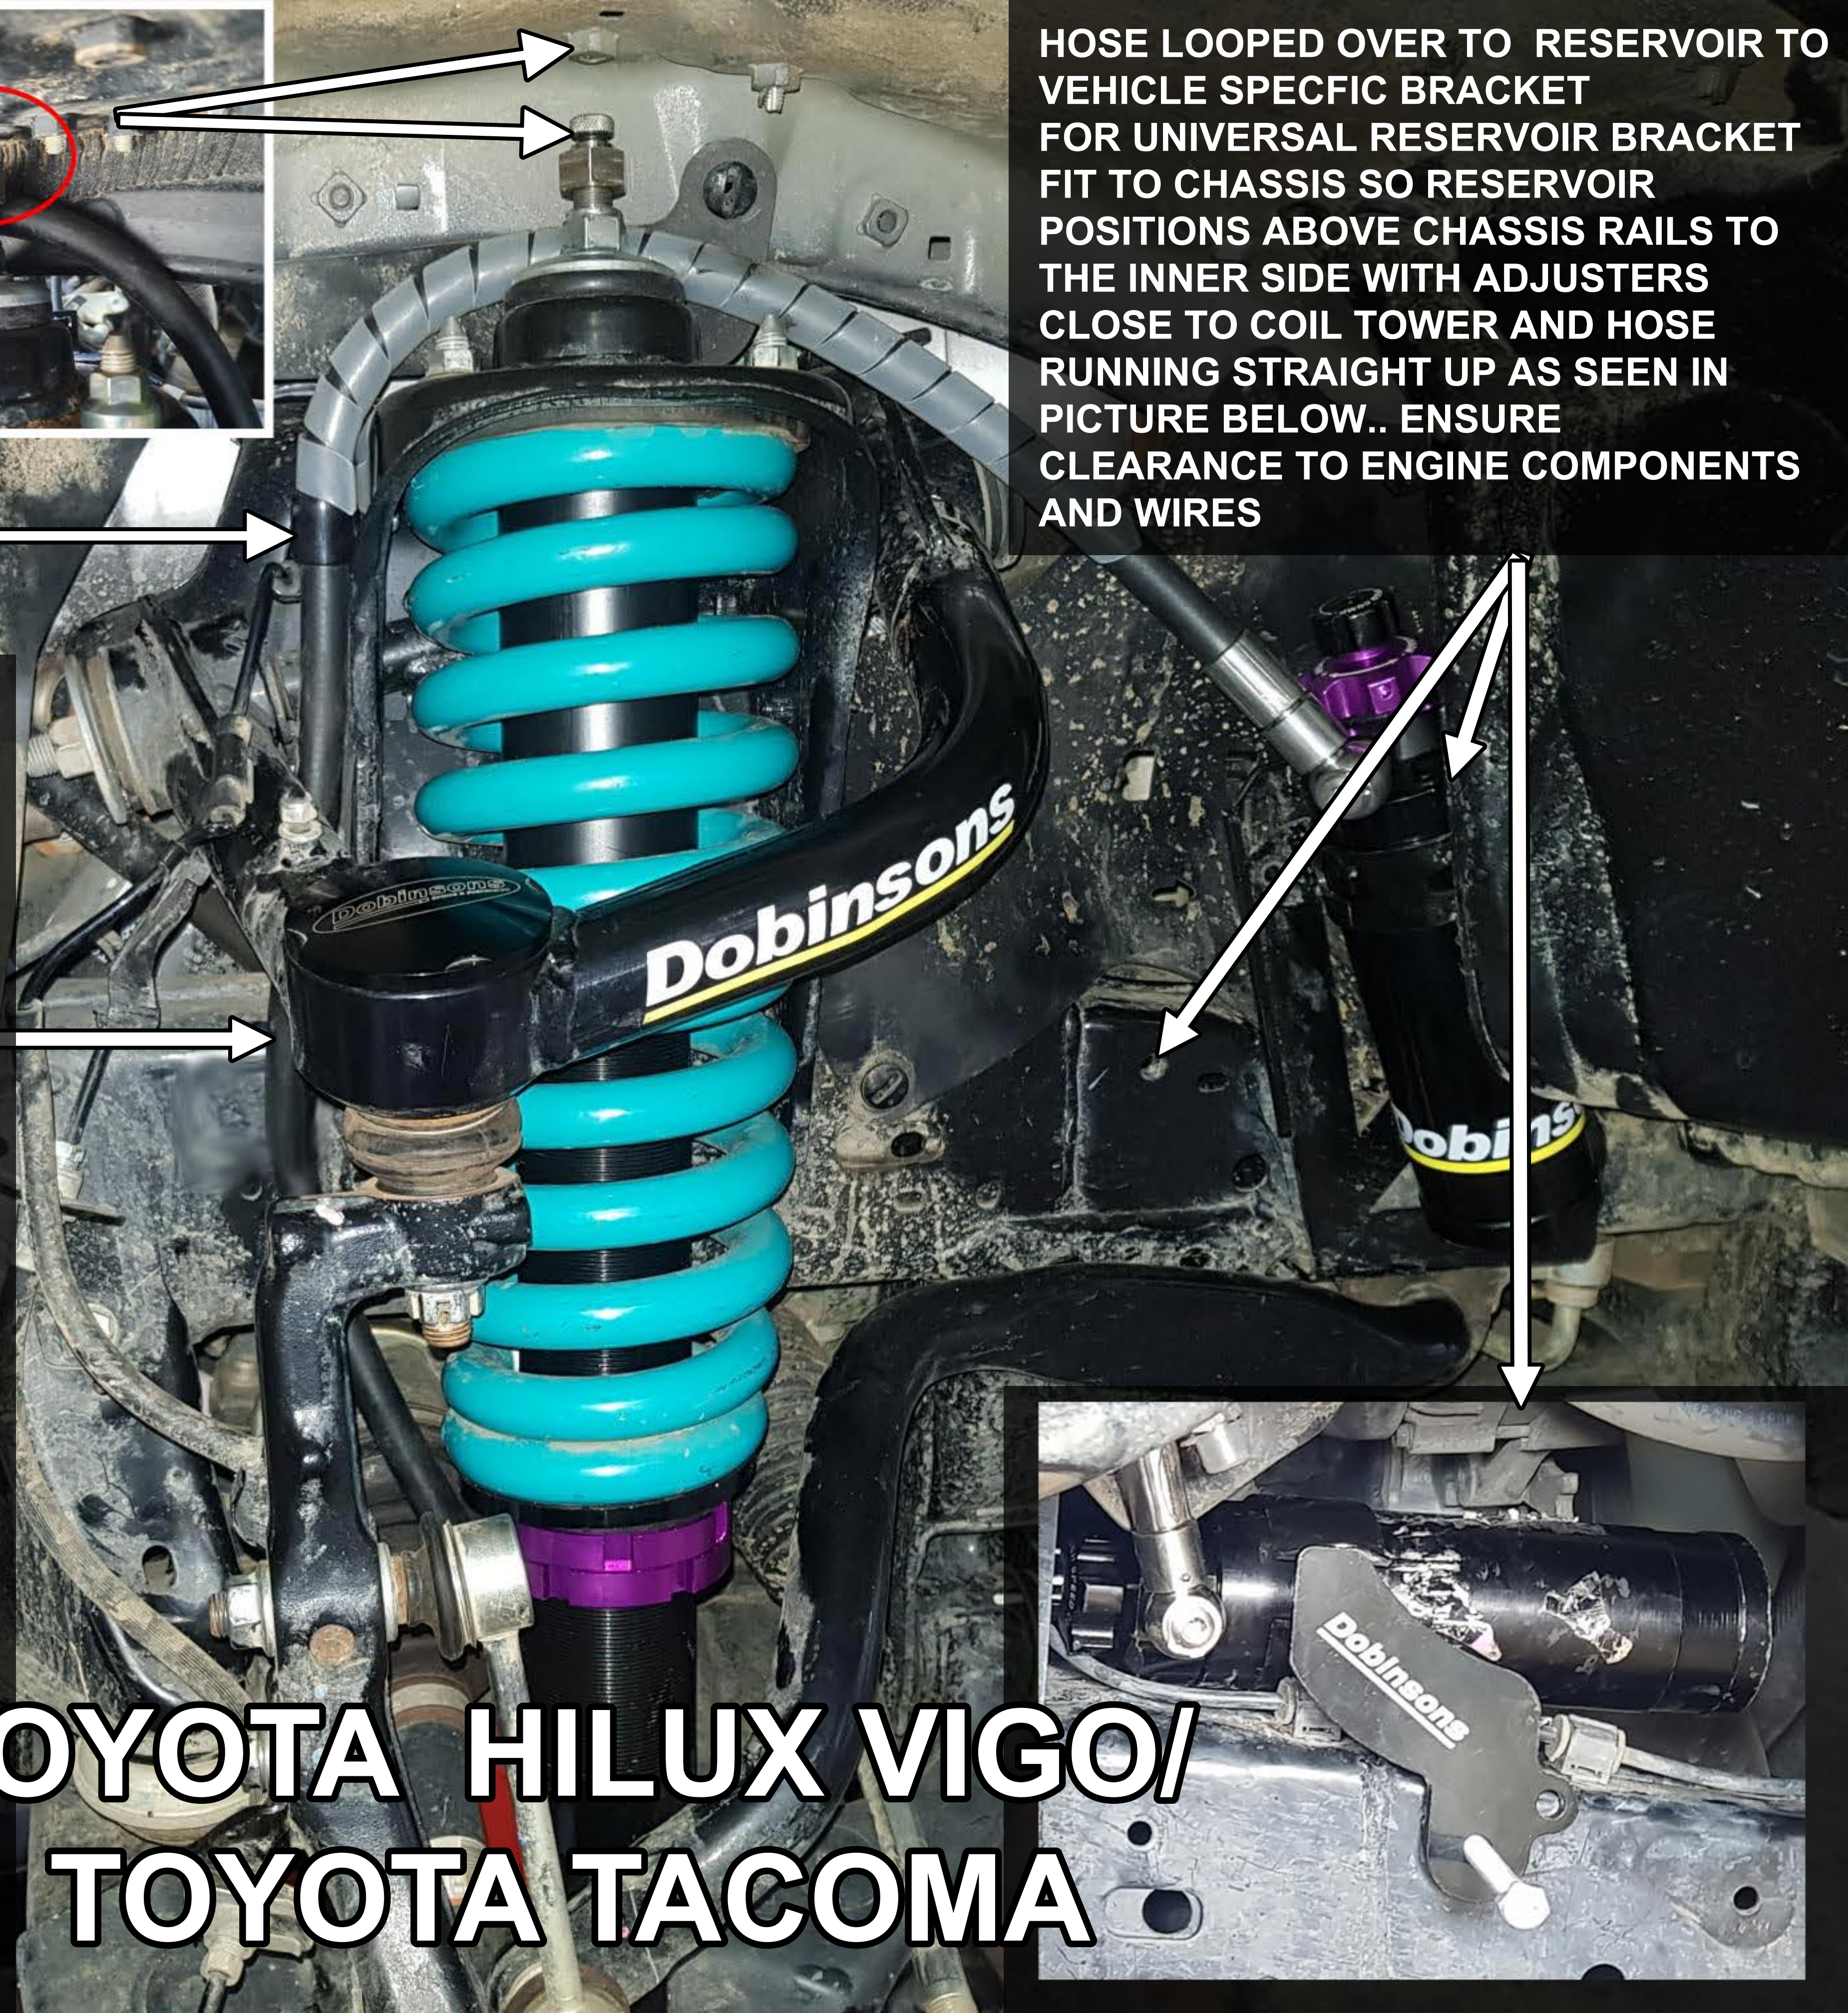
HOSE LOOPED OVER TO RESERVOIR TO VEHICLE SPECIFIC BRACKET FOR UNIVERSAL RESERVOIR BRACKET FIT TO CHASSIS SO RESERVOIR POSITIONS ABOVE CHASSIS RAILS TO THE INNER SIDE WITH ADJUSTERS CLOSE TO COIL TOWER AND HOSE RUNNING STRAIGHT UP AS SEEN IN PICTURE BELOW.. ENSURE CLEARANCE TO ENGINE COMPONENTS AND WIRES
